### 3.3 GEOHAZARDS AND SEISMIC CONDITIONS

This section presents information available regarding geohazards (geologic hazards) in each of the proposed Mine Site, Transportation Corridor, and Pipeline regions. Each alternative is examined by major project component: Mine Site; Transportation Corridor; and Pipeline.

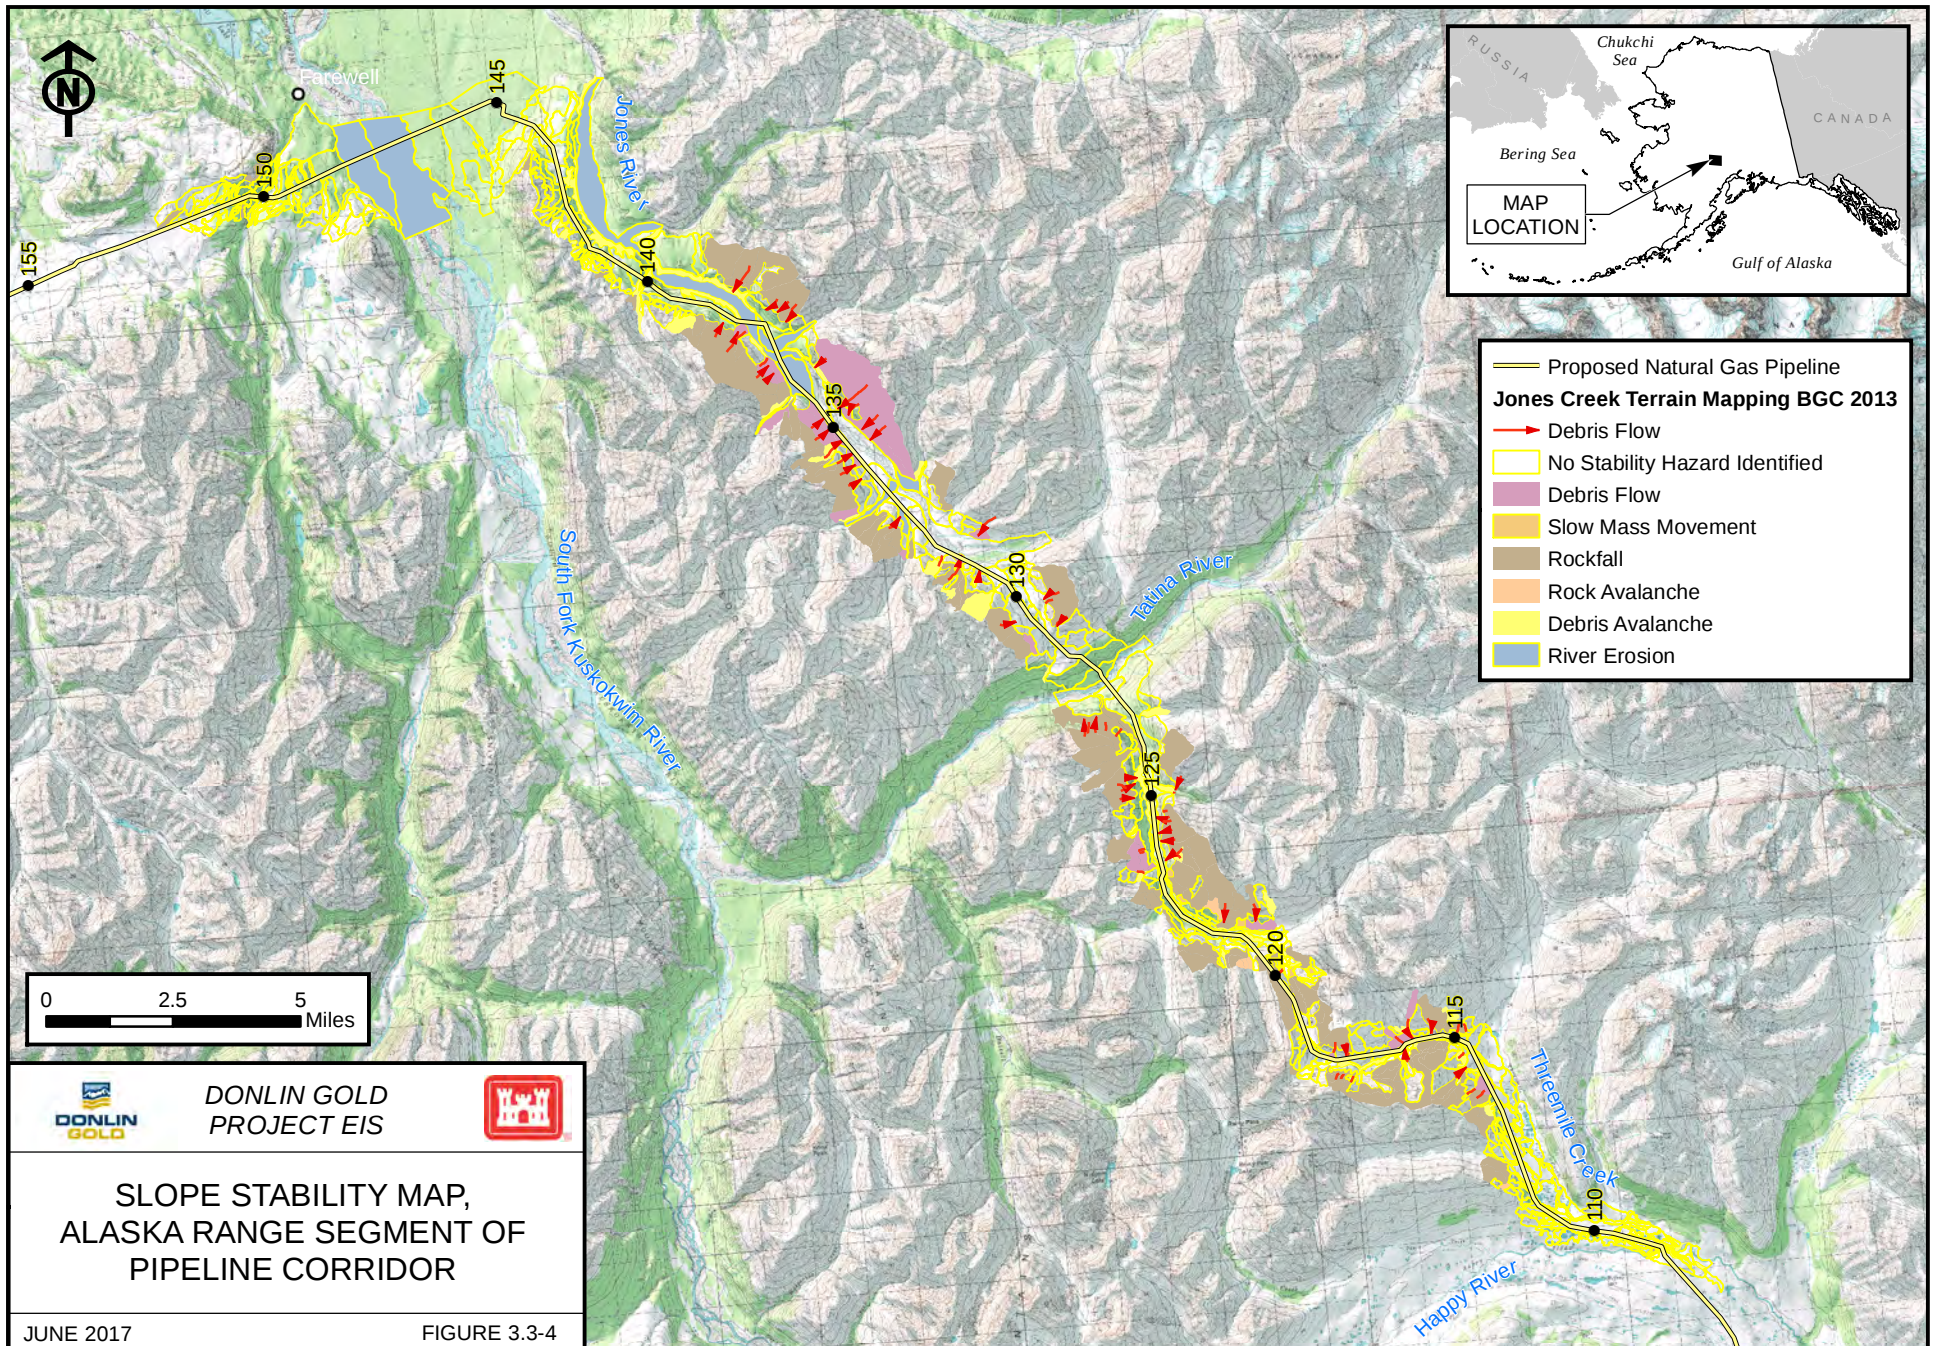
The HDD method was first introduced in the 1970s. Since then, systems have been designed that can bore pipe up to 48 inches in diameter, 200 feet below the surface, with 6,000 feet of horizontal distance. Several dozen projects have been already completed in Alaska with similar sized lines (for example, the Colville River crossing to the Alpine oil field). While HDD is typically best suited for small-diameter pipeline installation, it is considered to be a reasonable approach for this project as long as favorable subsurface conditions are present. If thick sequences of loose gravel soils containing cobbles and boulders, or highly fractured bedrock are present, the HDD procedure can become impaired, affecting drill advancement rates and increasing the difficulty of maintaining an unobstructed path for the drill string. The presence of either cobble-containing gravel soils or highly fractured bedrock may also cause loss of drilling fluid circulation, or release of drill fluids into the overlying water body, a condition referred to as “frac-out,” which has the potential to affect water quality in the river. The geotechnical conditions at individual proposed HDD crossings are described below, and the feasibility and frac-out risk associated with each are described in Section 3.3.2.3.

The proposed Skwentna River HDD crossing is approximately 2,500 feet in length, with moderate topography. The northwest shore has a gentle slope and the southeast shore consists of a small hill with moderate slope. The river crossing location consists of two channels separated by a gravel bar. There are bedrock outcrops on both sides of the river, which lie within 3,000 feet from the alignment on the southeast bank. Previous investigations identified a clay layer at a depth of approximately 50 feet as the target zone for HDD pipe installation.

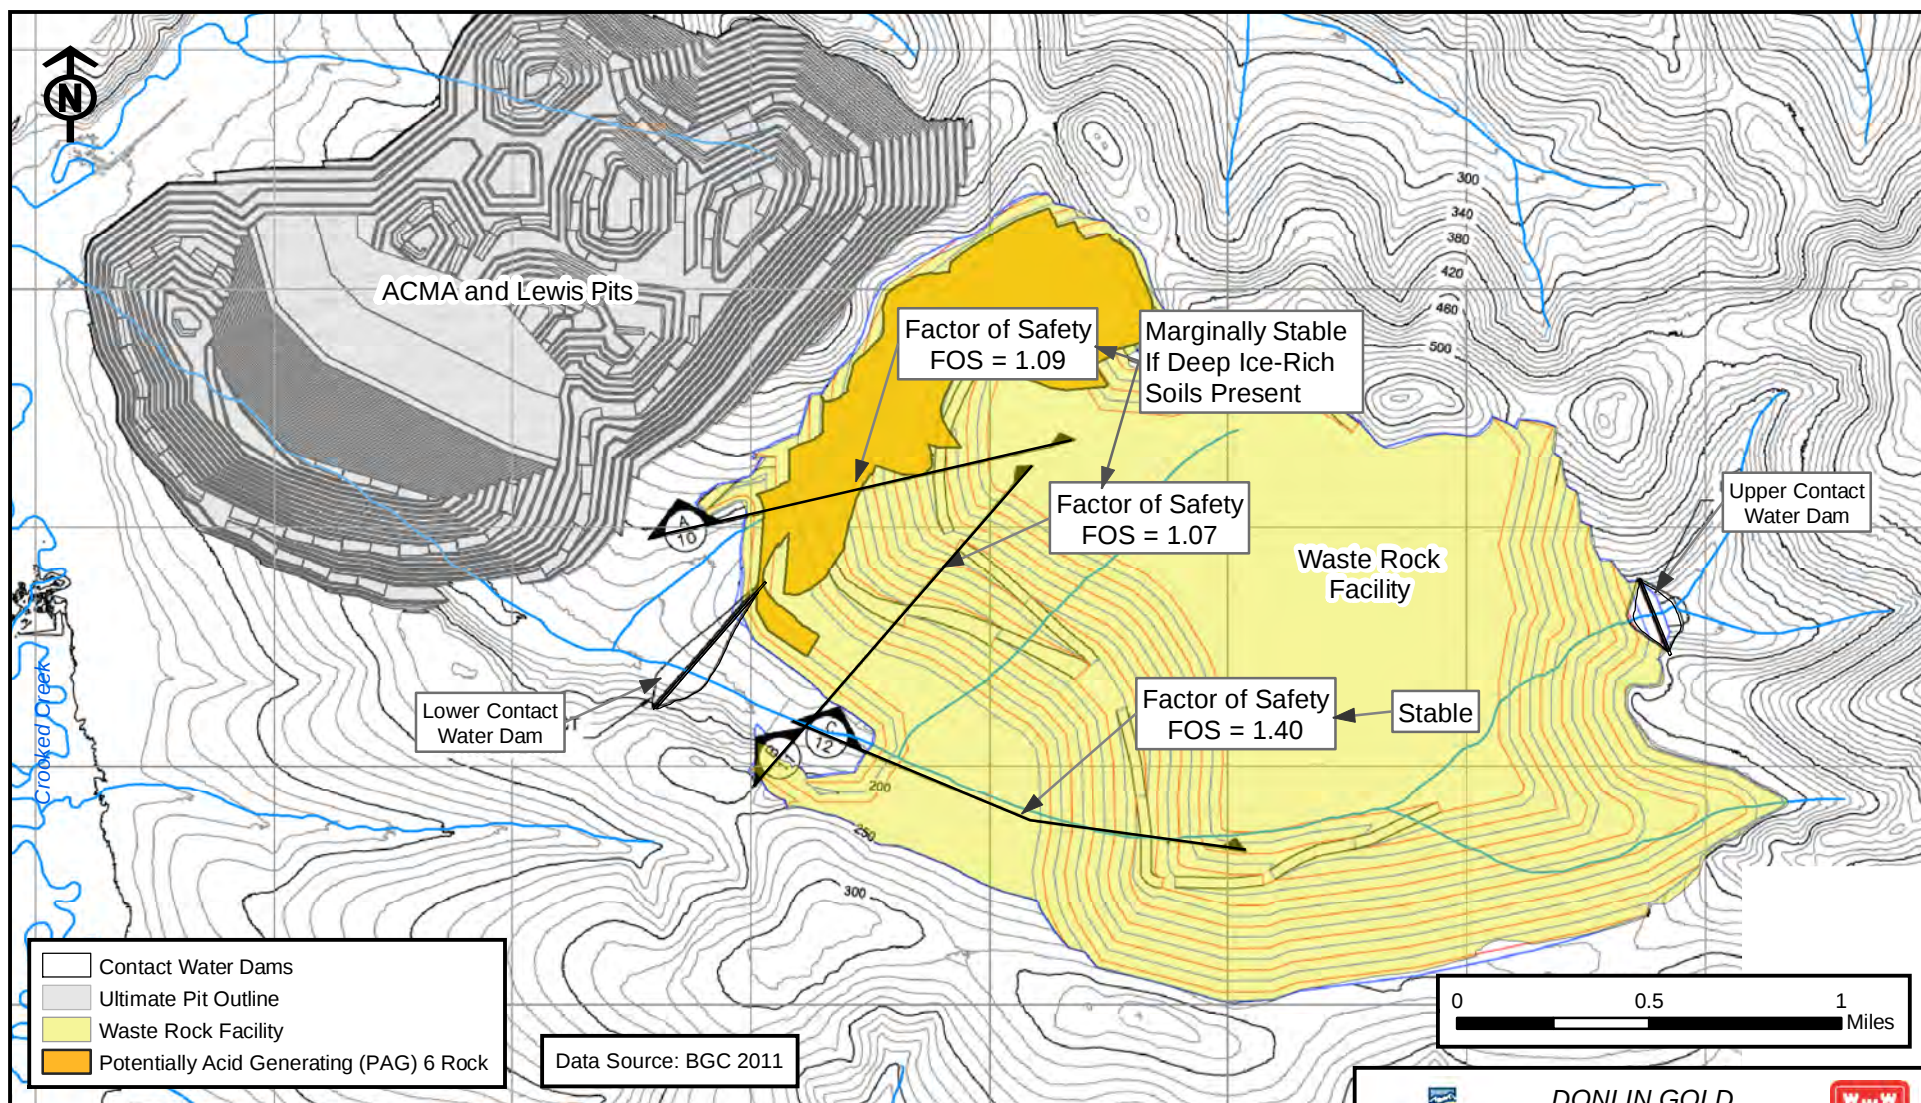
Notes:

1. Factor of Safety (FOS): < 1.0 Unstable, = 1.0 Stable, > 1.0 Stable with a Safety Factor
2. Results of pseudo-static analysis based on 7.8 magnitude earthquake with a 0.4g horizontal peak ground acceleration (5,000 to 10,000 year return period).
3. Foundation preparation consists of the excavation of ice-rich loess to 8 ft and backfill with coarse waste rock.

The proposed WRF would be located in the American Creek Valley southeast of the pit and constructed in 100-foot lifts. The planned maximum dump height is approximately 1,115 feet from the toe, with the elevation of the top lift at approximately 1,700 feet (SRK 2016d). The WRF would include up to 8 percent by volume of overburden materials that could weaken the strength of the stacked and compacted waste rock. The stability of the WRF was evaluated under a major earthquake scenario using both pseudostatic and dynamic methods. The MCE used in the analysis was a 7.8 magnitude earthquake with a pga of 0.4g, which represents a return period in the range of 5,000 to 10,000 years.

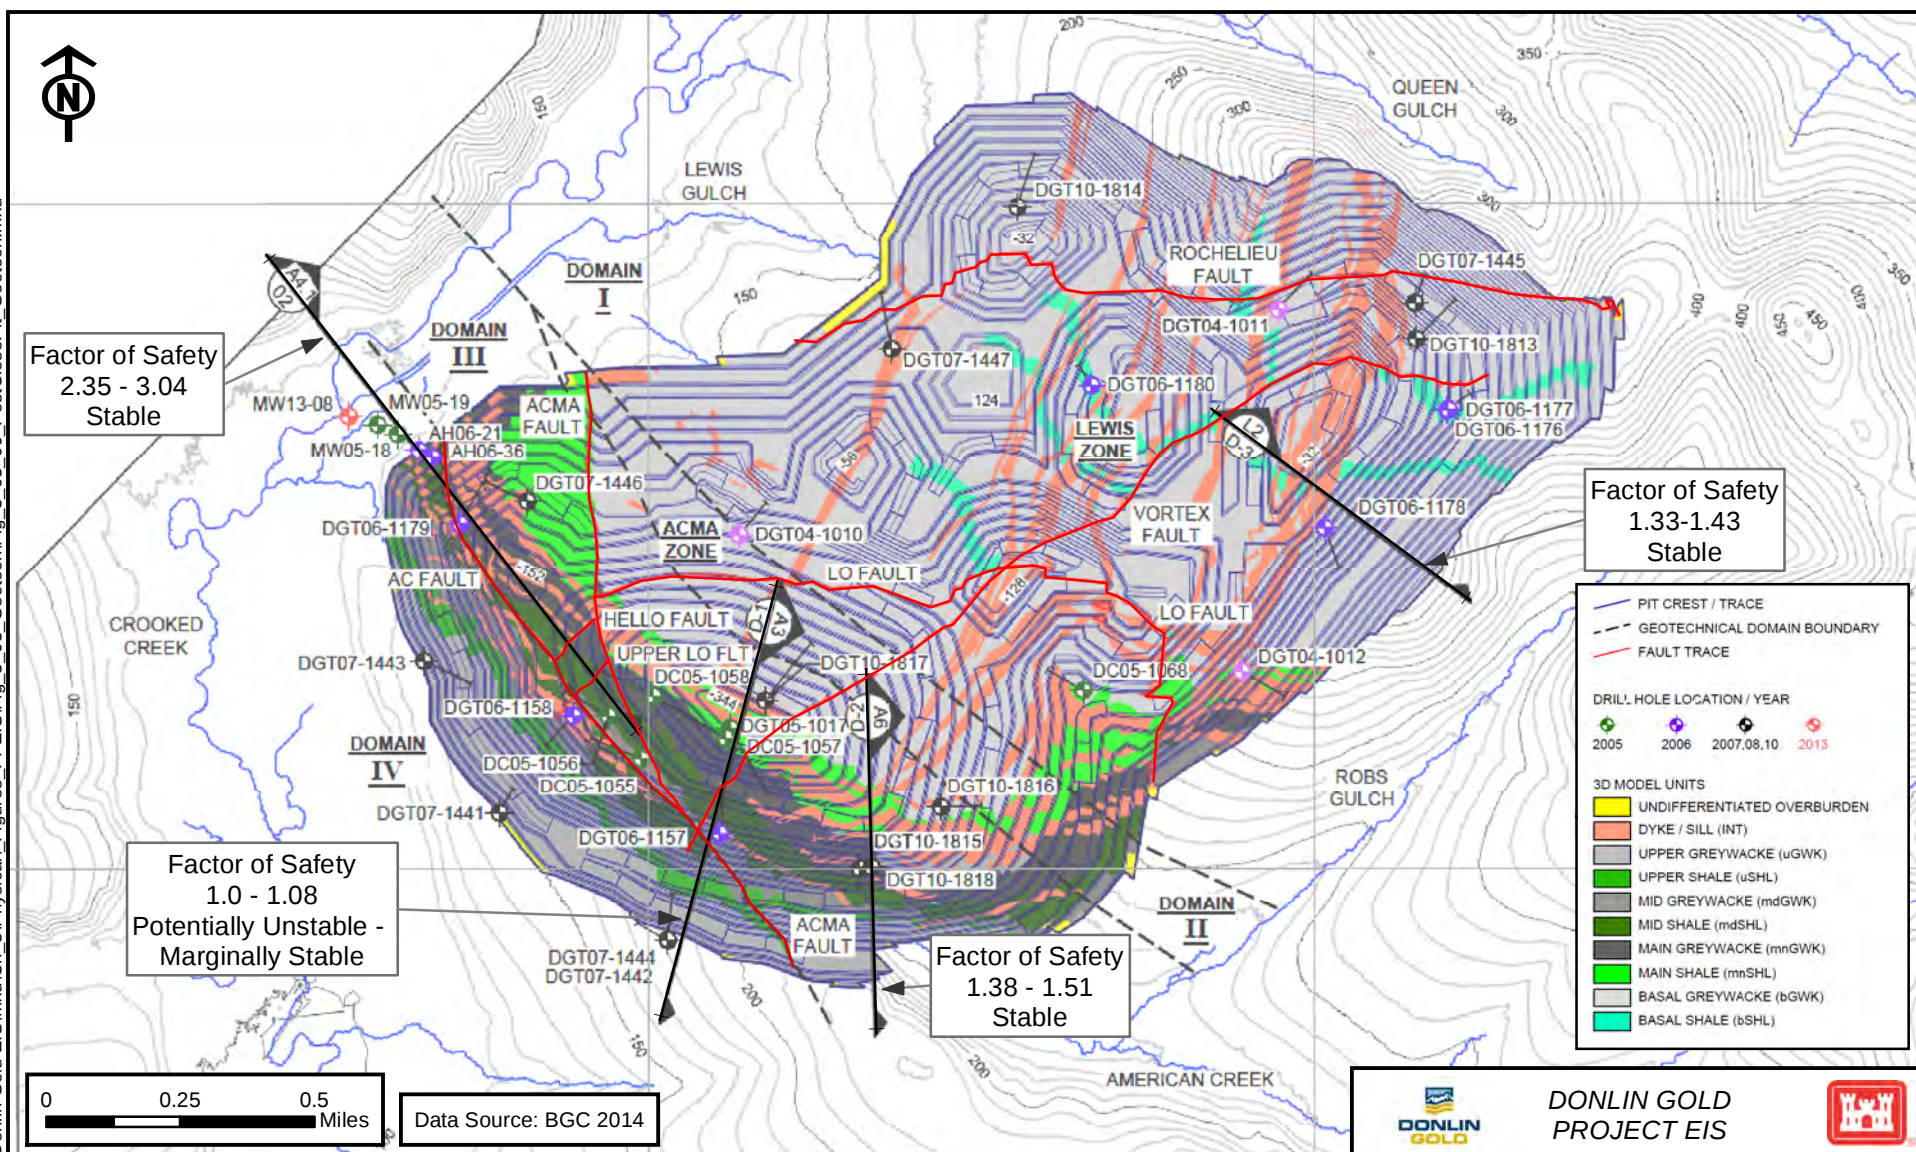
**Notes:**

1. Factors of Safety (FOS) under full and partially full pit lake conditions:  $\leq 1.0$  Unstable,  $> 1.0$  Stable
2. Results of pseudo-static analysis based on 50% of 475 year return period earthquake at 0.05g horizontal peak ground acceleration.
